# Macquarie Chapel Presbyterian Church Learning Centre Development

Congregation Information Pack  
January 2016

## **Property Re-Development Stage 1 – Church Extension**

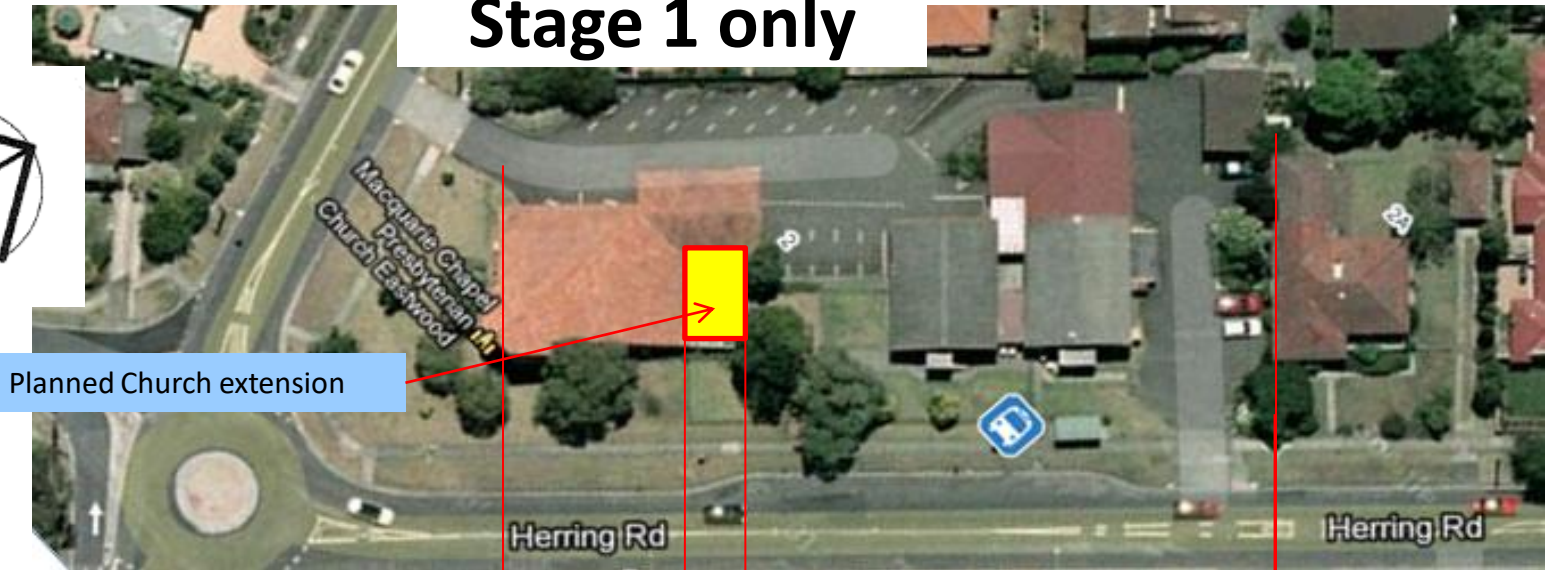
Planned Church extension

Existing site &  
proposed site plan  
Refer also drawing  
12-067 S-01 for  
specific detail of  
demolition in relation  
to new building  
alignment (Sheet #37)

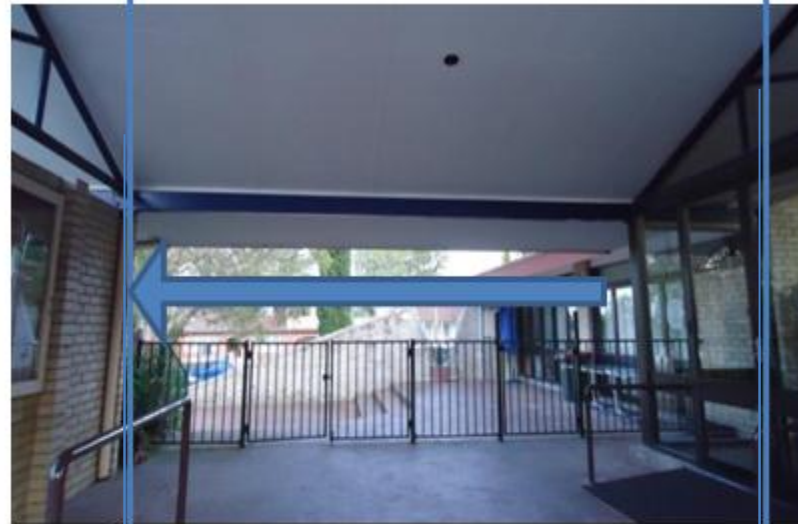
Line of Church roof extension  
Start slope change over line of internal wall near level of the ridge of the entry awning roof

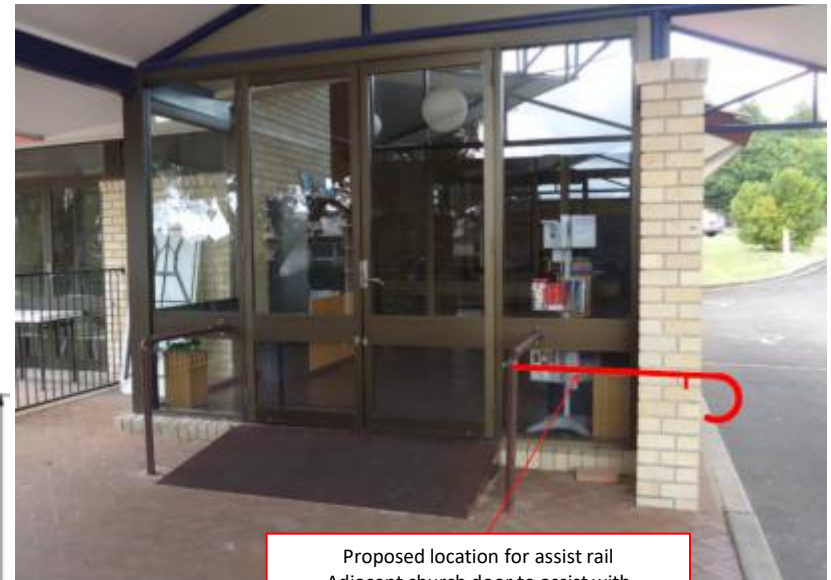
- Install kerb ramp between existing driveway & the existing covered entry area at church doors
- Remove the existing ramp & rail
- Install new assist rail adjacent the church door

Proposed location for assist rail  
Adjacent church door to assist with  
stepping up the kerb

The existing ramp &  
rail will be removed

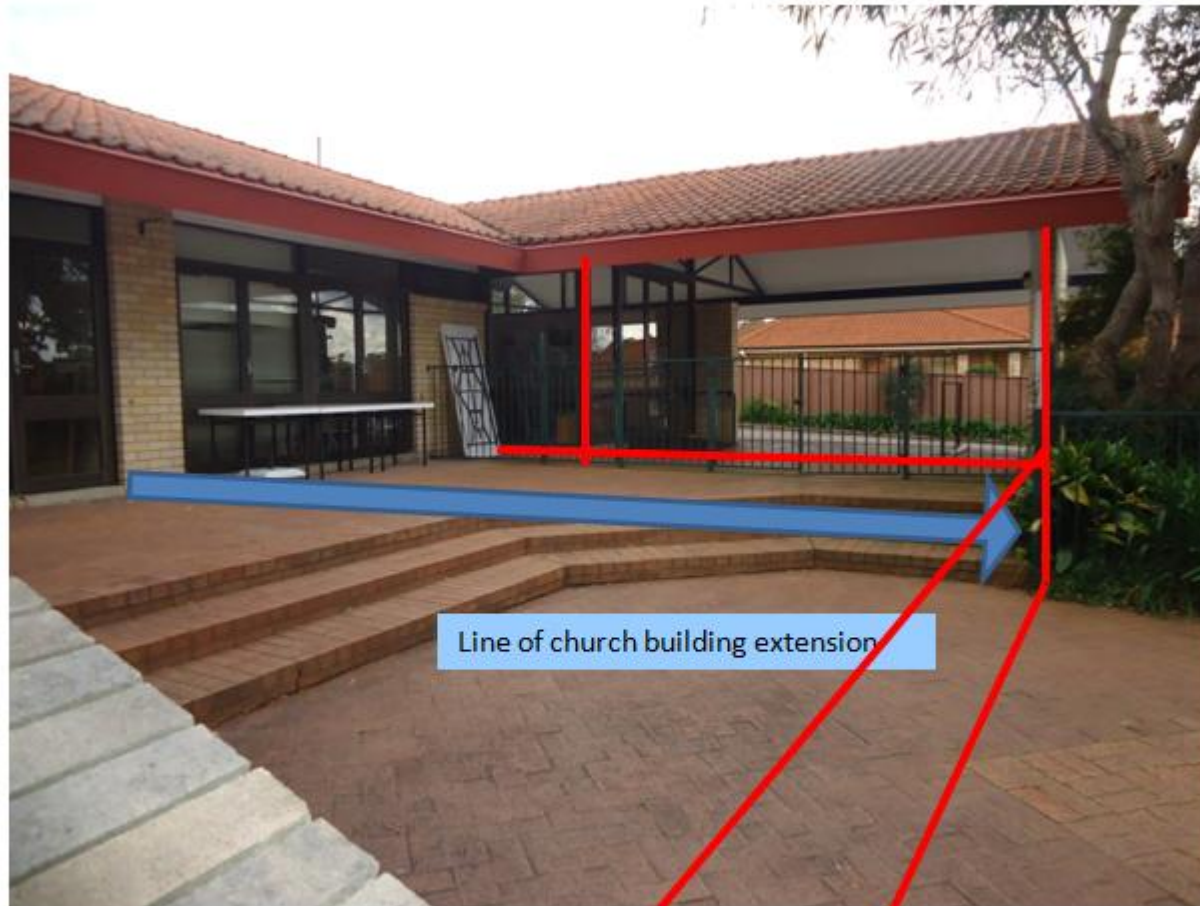
Church office area expansion + entry/lobby - view from  
Herring Rd toward car park

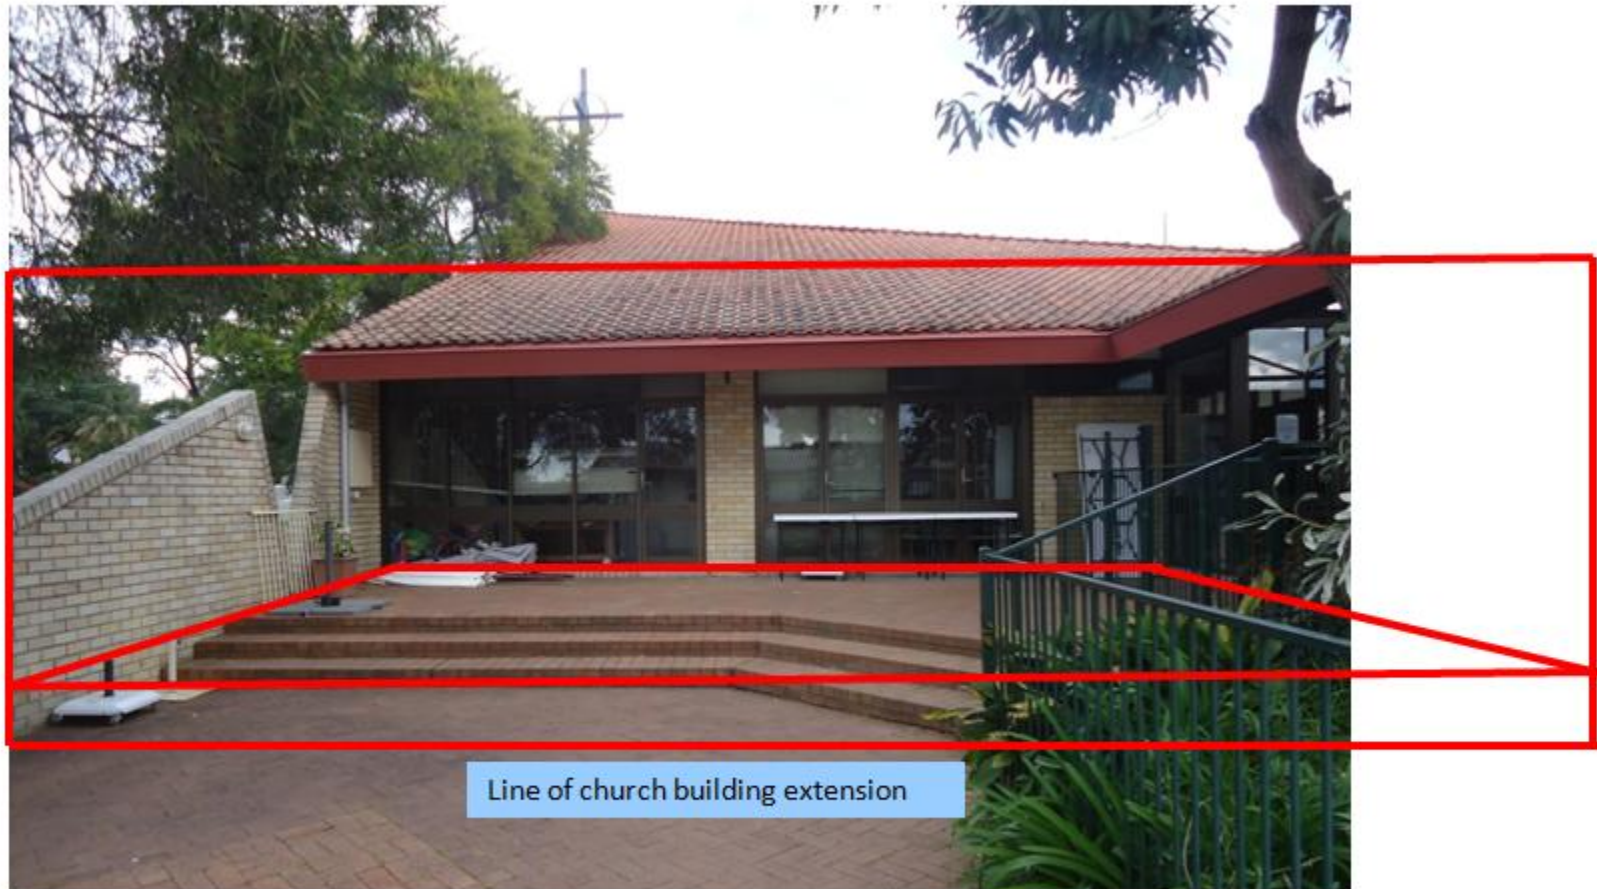
Area to be extended providing additional worship support space & meeting rooms.  
Note new roof completely over existing impervious paved area

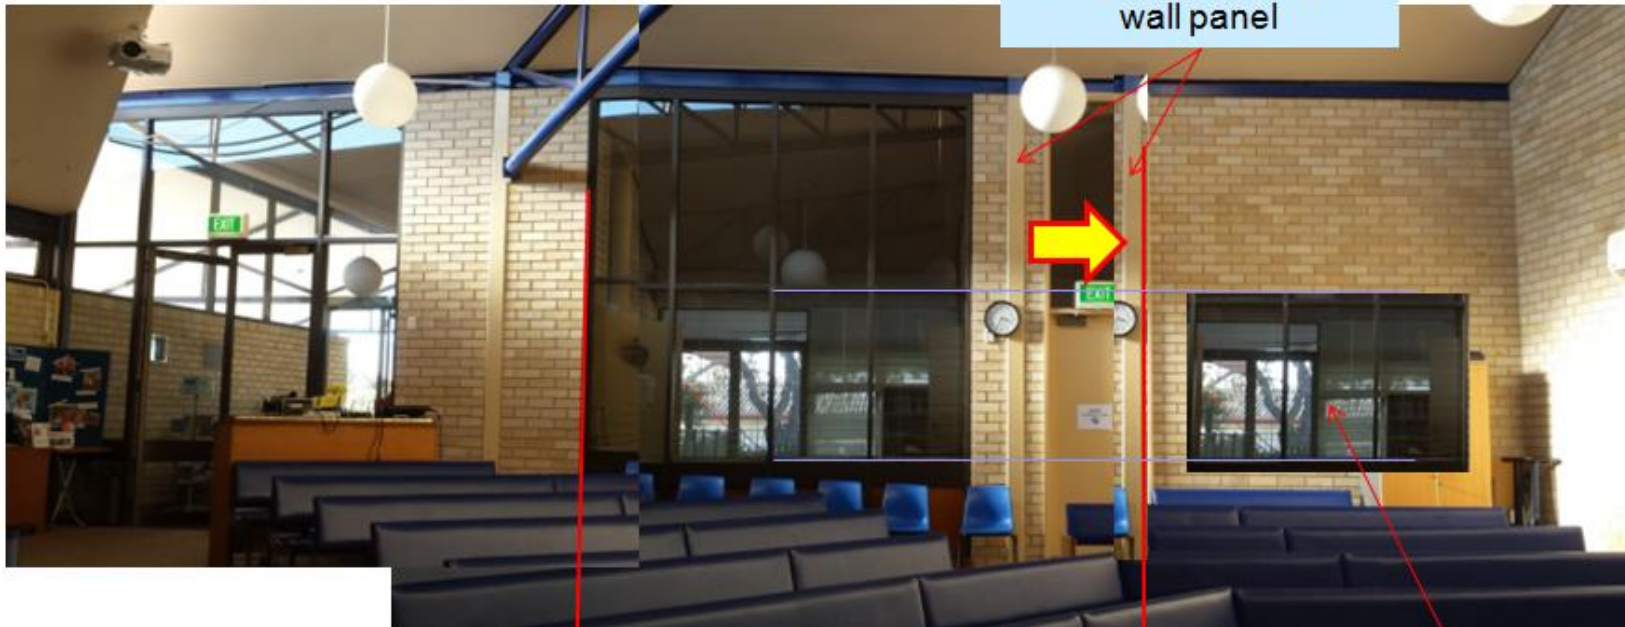
Detail changes to the wall between  
worship space and new extension

Reposition the 150mm  
structural column to  
end of existing brick  
wall panel

Remove completely this section of wall  
& replace with nominal 5 panel multi  
folding acoustic rated screen

Remove and relocate/ or  
provide new, glass panel  
in the brick wall to the  
repositioned general  
office room

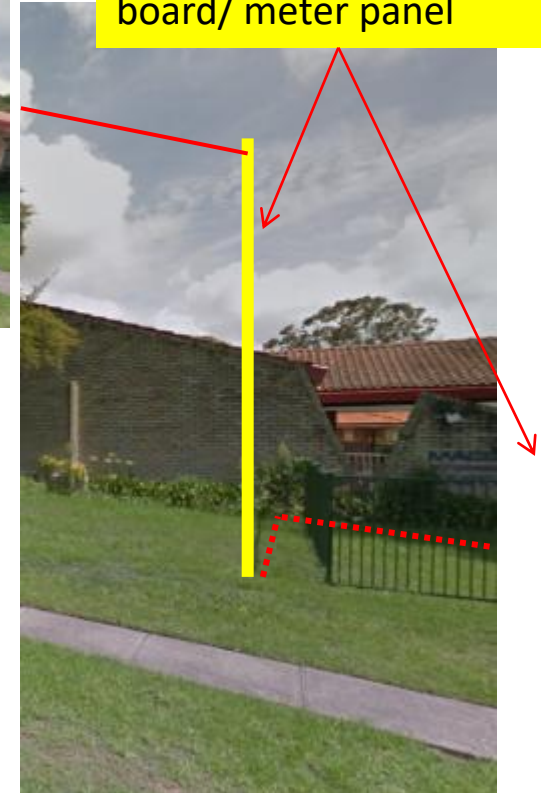
**New power supply**  
From pole on east side of road to site pole then underground to church wall

By establishing a new supply we can progress with an upgraded supply with no disruption to existing supply/ operations until the new service is in place – then disconnect existing supply to hall/site.  
Use existing conduit runs from current switch board to the church to return power to halls from new main power connection

**New site power pole at boundary then underground to church wall & new switch board/ meter panel**

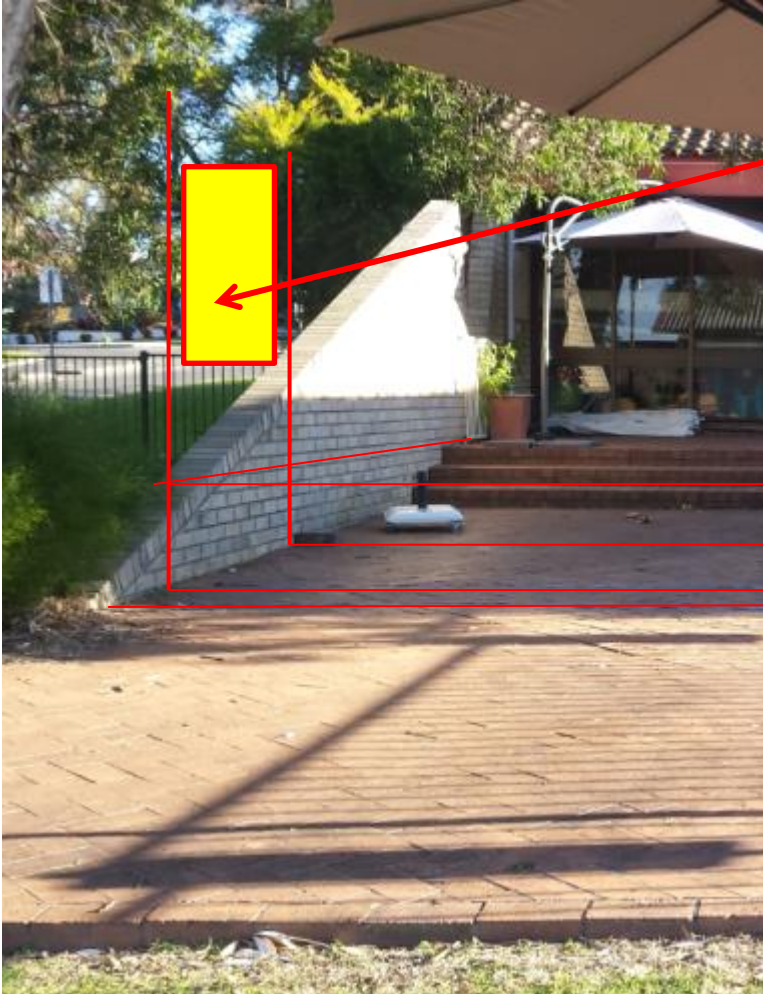
Locate the new main switch board for site & meter panel on the covered veranda of the Herring Rd wall of the extended building.

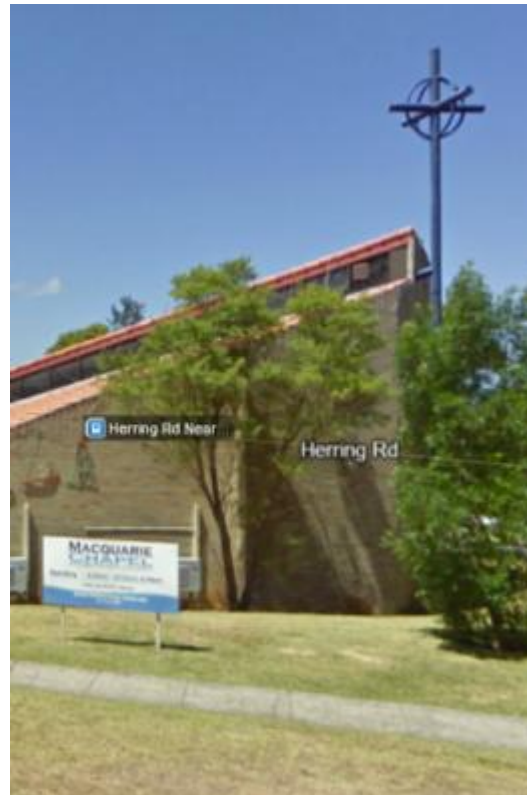
Tubular steel structure 11m long with the top of the cross 14m above the church entry floor level

Cross viewed from Abuklea Rd

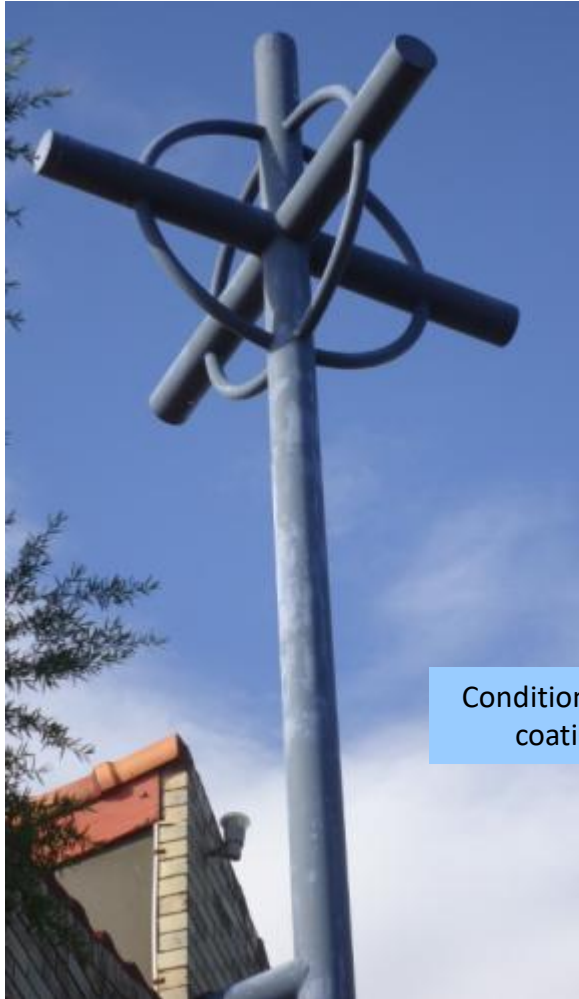
Condition of cross protective  
coating- 'paint work'

1. Repair corrosion damage to existing external metal cross on apex of the church building
2. 'Repaint' the repaired metal cross – exterior grade epoxy type finish to give minimum 20 yrs service life. Colour to match original 'paint ' colour.
3. Replace gutters & down pipes to the church roof at high sanctuary windows – see photos
4. Remove asbestos cement sheeting on the soffit of the church entry awning, as required. Reline awning and paint if sheeting has to be replaced.

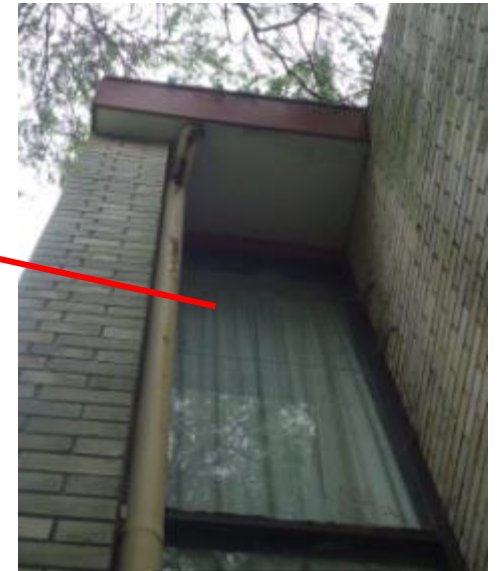
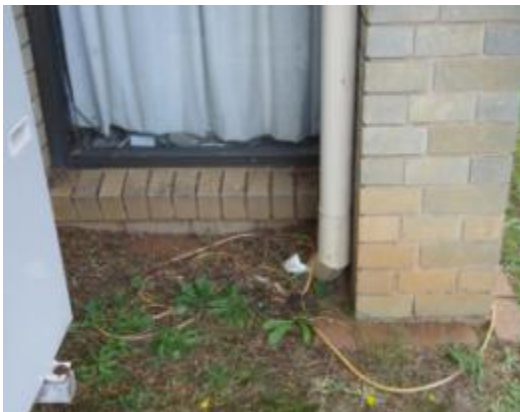
Location of the 2 full height window panels

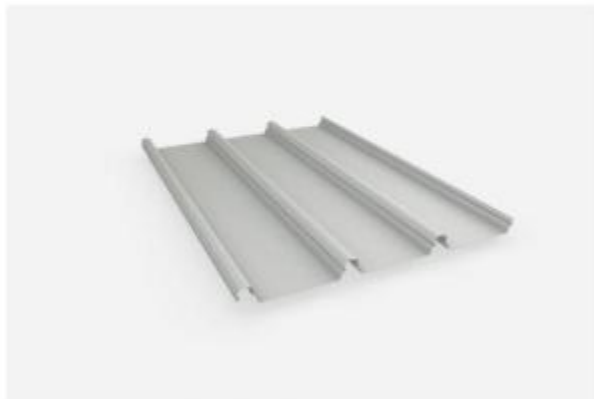
## KLIP-LOK 700 HI-STRENGTH®

An advancement of the original concealed fix roof cladding with bold ribs making a strong visual statement rising from flat pans. It is a superior product which has earned FM Global approval.

- Concealed fixed offering supreme watertightness
- Can be used with **LOK-KLIP®** end and expansion joint system
- Nominal cover width: 700mm
- Minimum roof slope: 1° (subject to design provisions being met)

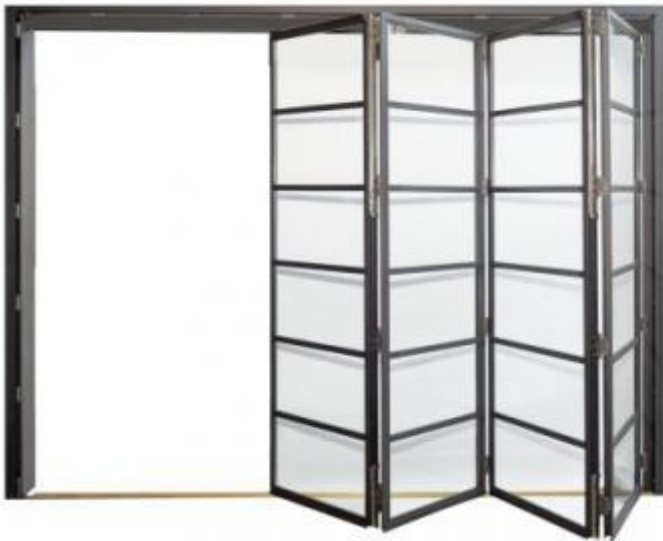
Indicative image only – clear glass folding doors with anodised aluminium frame or similar and nominal wide mid-rail/ chair rail at safety height.

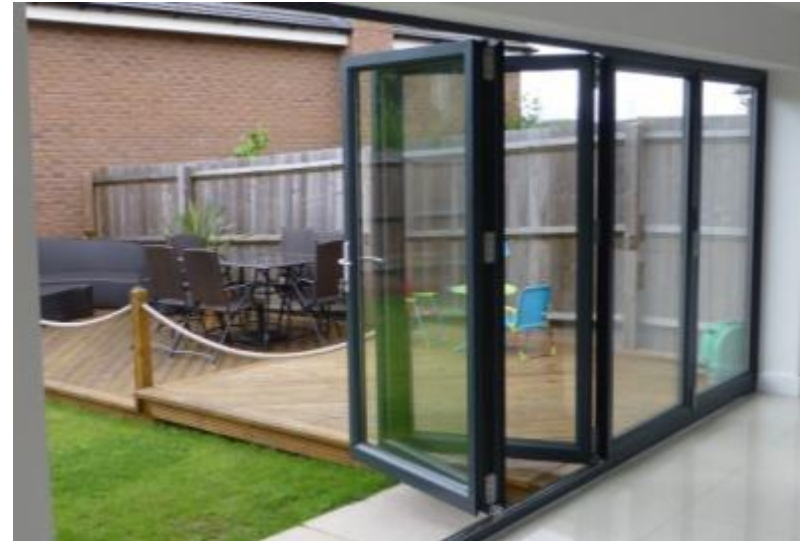
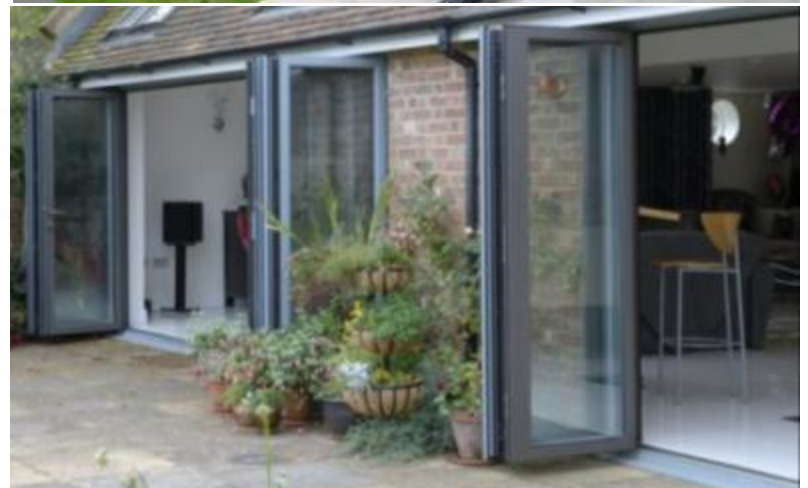
BRONZE  
INTERNAL  
THROW BOLT  
MECHANISM

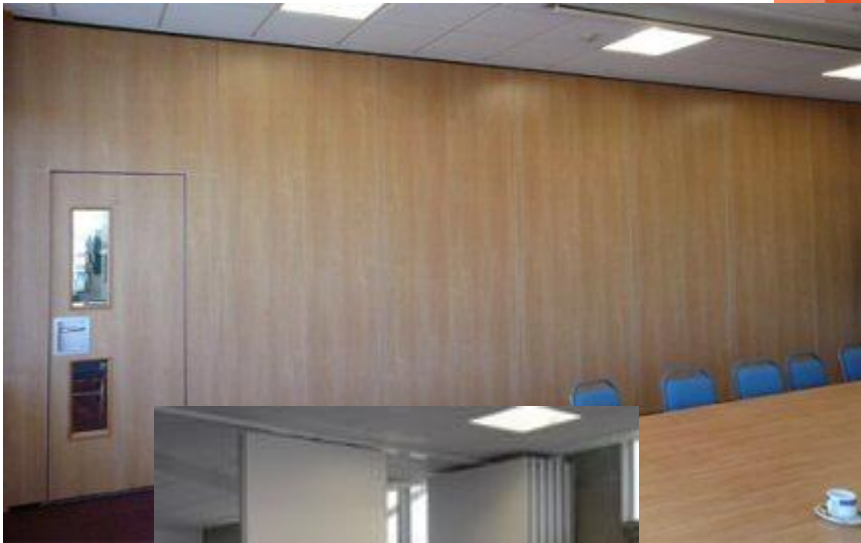
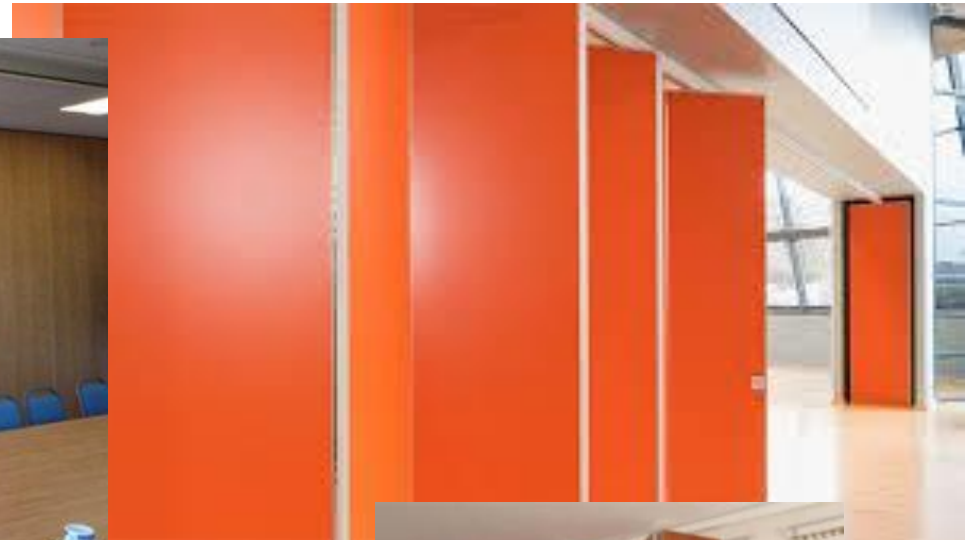
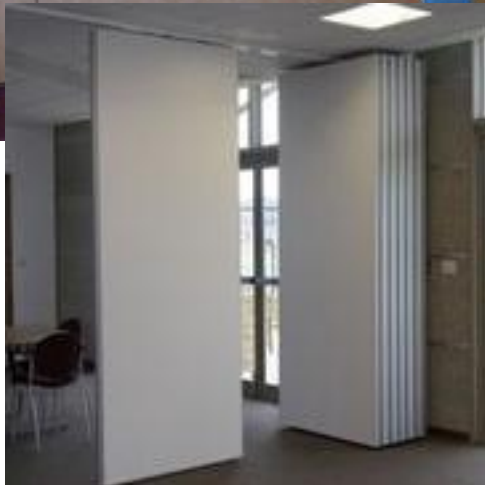
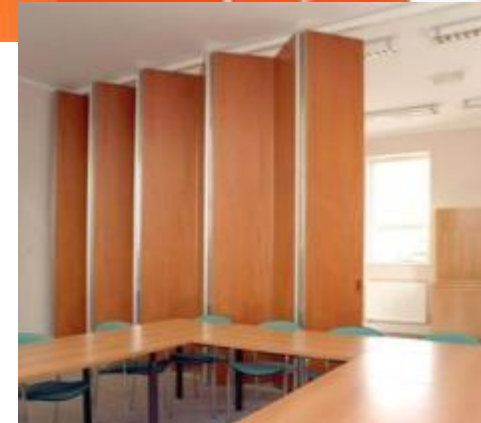
Multi panel folding acoustic partition – indicative images only

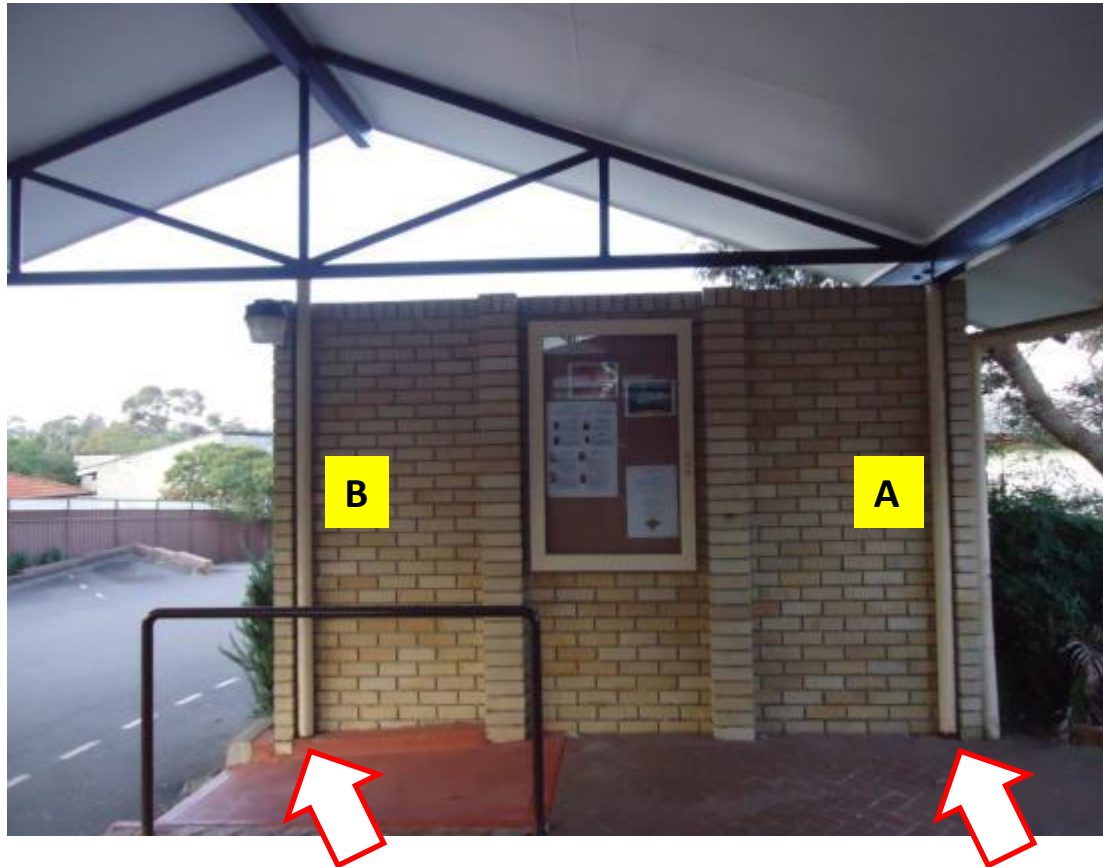
## Extent of corrosion

- Rust visible at ground level of both posts on the existing northern support frame
- Pavers lifted at Post A - 22 Aug 2015 to assess extent of problem & degree of damage to the posts
- Note for reference to the structural frame of the church building (Taylor Thompson & Whitting Drawings)
  - Column A = C11
  - Column B = C6

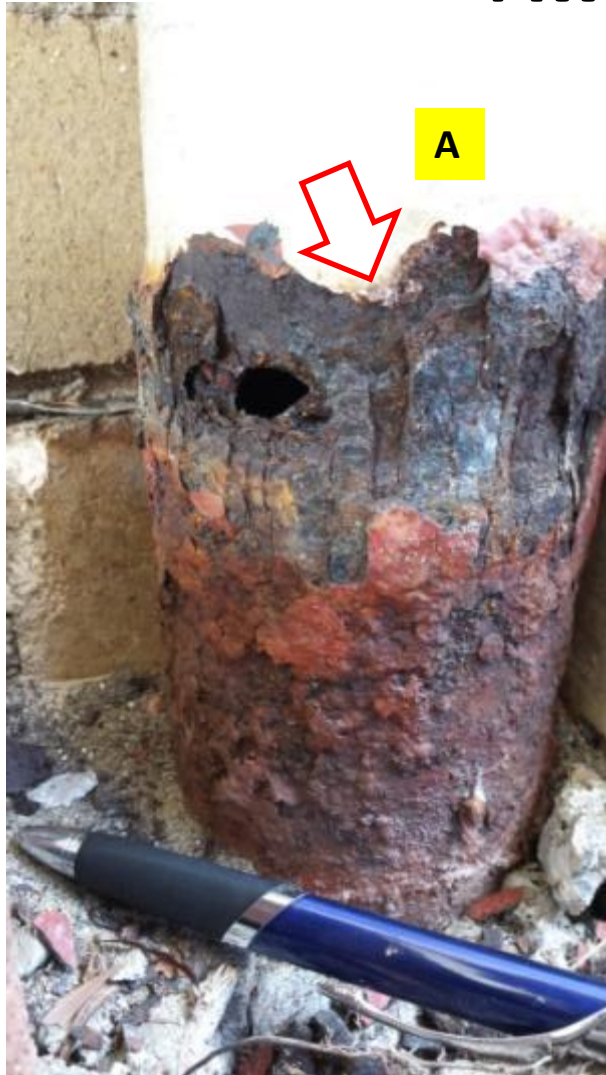
## Extent of Corrosion – Post A

- Total circumference of circular tube post badly corroded from ground level to start of concrete encasement
- Full depth corrosion has occurred – rust flaked away revealing holes in tube

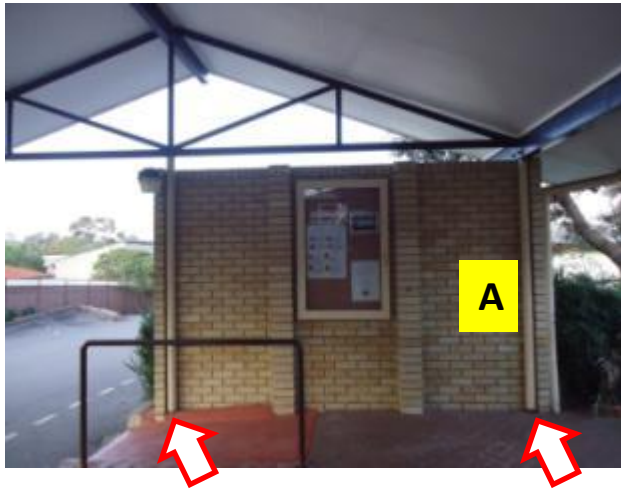
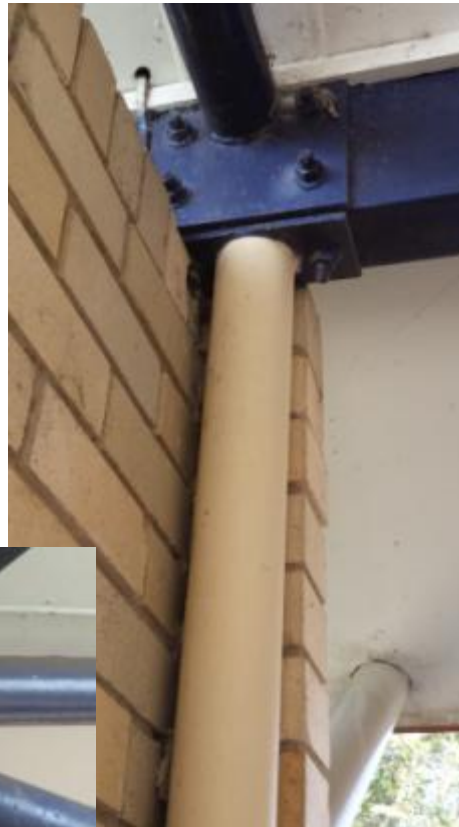
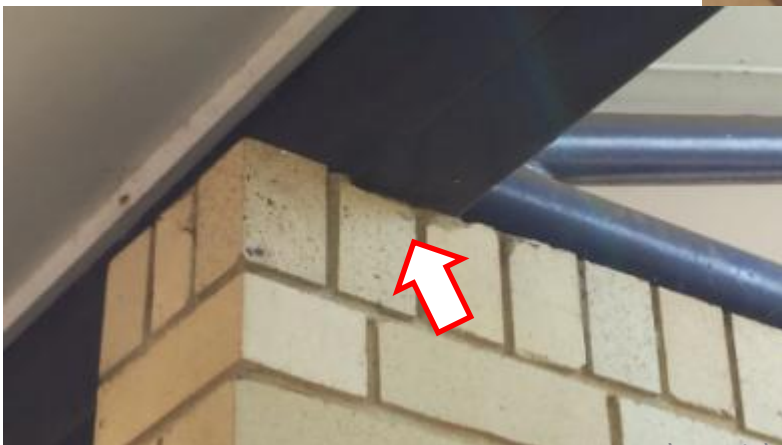
## Frame Details

- Column head is bolted to eave beam/ roof truss
- Some if not all of the brickwork would need to be removed to allow column(s) to be replaced
- Note: the brick wall is not incorporated into the planned building works of the church & the future site development
- The eave beam of the awning roof frame appears to be sitting onto the brick wall
